# WOOD DESTROYING PESTS AND ORGANISMS INSPECTION REPORT

BUILDING NO. <b>3182</b>	STREET, CITY, STATE, ZIP <b>Ross Avenue, San Jose CA 95124</b>	Date of Inspection <b>4/12/2017</b>	No. of Pages <b>7</b>
-----------------------------	---	--	--------------------------

General Description: A one story, wood framed, single family residence with stucco and masonry siding exterior.

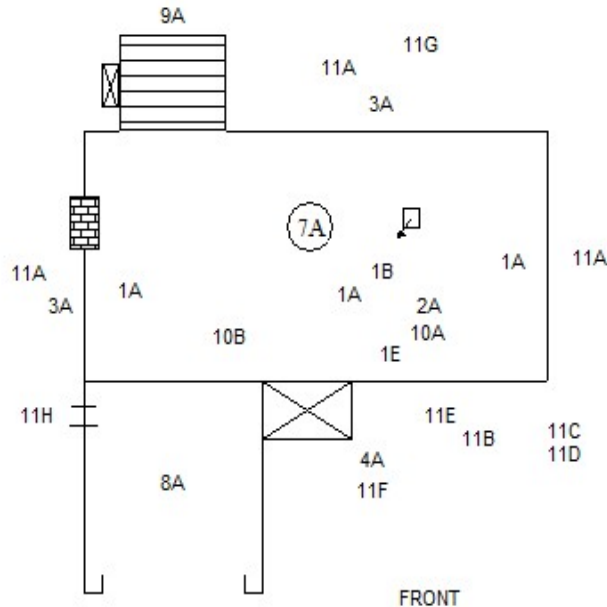
DIAGRAM NOT TO SCALE

ITEM 11E FINDING: Fungus and fungus damage were noted at the 2"x 4" rafter tails at the area indicated on our diagram.

RECOMMENDATION: Remove the damaged wood members and replace with new materials, sealing all voids. The repaired areas will be primer painted only.
